Building Safety Case Report

Moorcot Court

Revision Date September 2023- Draft.

Principal Accountable Person	Wythenshawe Community Housing Group	8 Poundswick Lane, Wythenshawe, Manchester M22 9TA
Point of Contact	Building Safety Manager- Vic Finn	07525905048
Updating this Report	By: Vic Finn	When improvement work is carried out or following a major event.

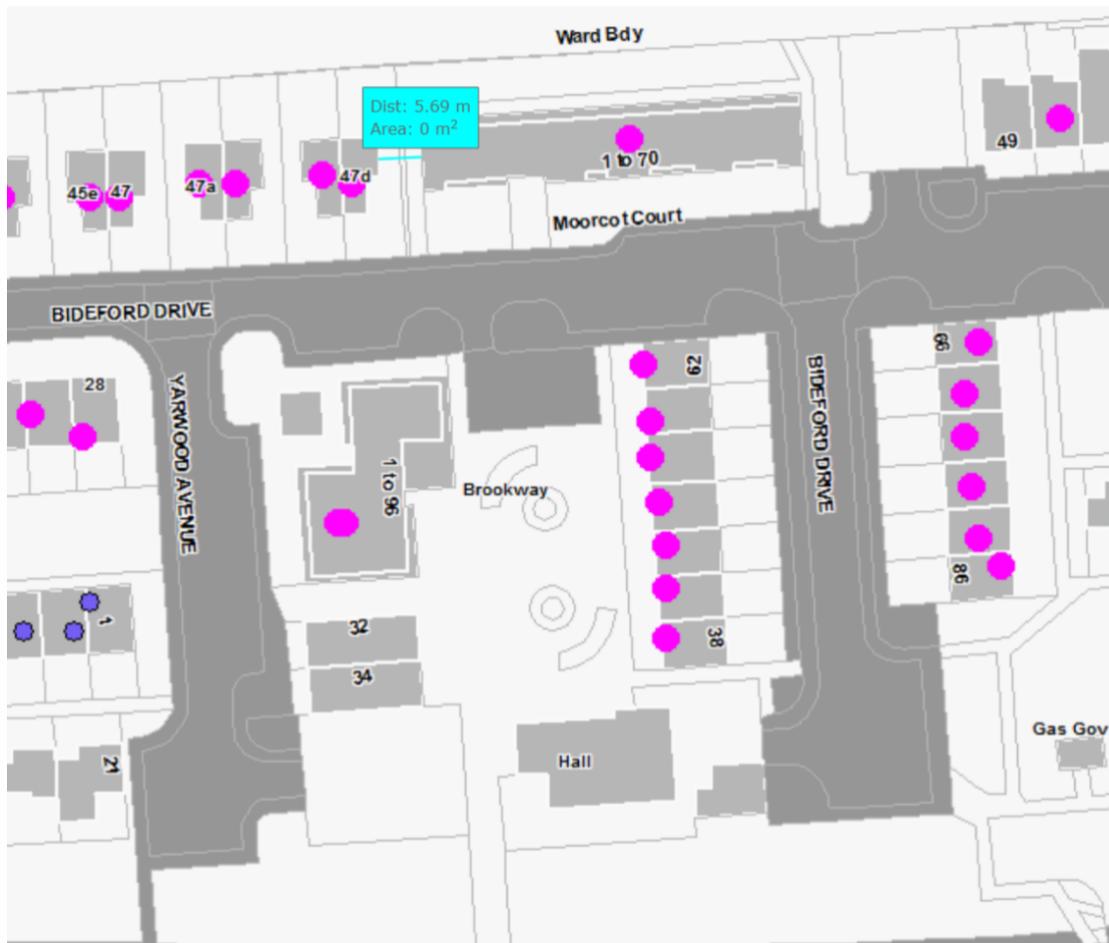
Moorcot Court is situated approximately 5.69m away from the nearest residential building and 19.6m away from Brookway court.

The OS map below shows where the measure of distance from the block to the nearest property is taken.

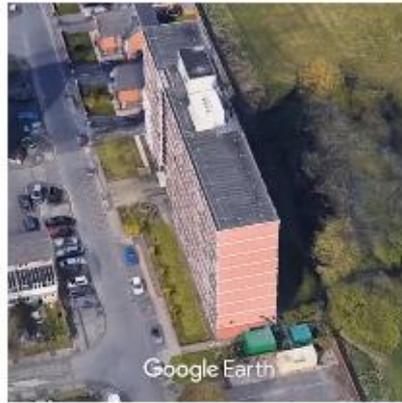
Moorcot Ground

MCFG002		Passed	20/10/23
Fire glass fitted	Intumescent strip fitted & no damage	Door closes properly	
Yes	Yes	Yes	
Gaps over 4mm around the door	Fire door keep shut sign installed	Damage to the fire door	
No	Yes Both Sides	No	
MCF3001		Under repair	20/10/23

if any repairs are identified, these are raised in the housing management system and allocated to one of the trained Fire door maintenance technicians or sent to qualified and competent, external contractors.

Further below is a screenshot of the same door when checking on the live status and also showing a door that is under repair. The status is updated when repairs are carried out and signed off.

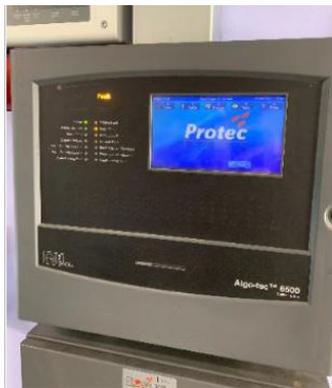
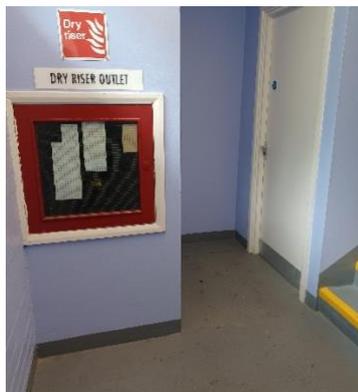
As shown on the fire strategy drawing, Moorcot court has the following firefighting equipment which has monthly visual inspections:

- 1 x modified lift for firefighters use.
- inlet and outlet for dry riser mains.
- Permanently open vents are located in the stairwell.
- Fire detection and alarm systems also linked to ancillary rooms.
- Automatic door release mechanisms linked to fire alarm systems.
- Sprinklers in high risk areas.
- Fire Alarms and notification panel for the BS5839-1 system, See **Appendix C** for cause and effect matrix

The above provisions will be visually inspected on a monthly basis to compliment the main inspections by suitably qualified contractors as in subsection '*Maintenance and equipment responsibility*' above.

Fire Strategy drawings of the building show where the equipment is located, refer to **Appendix A**.

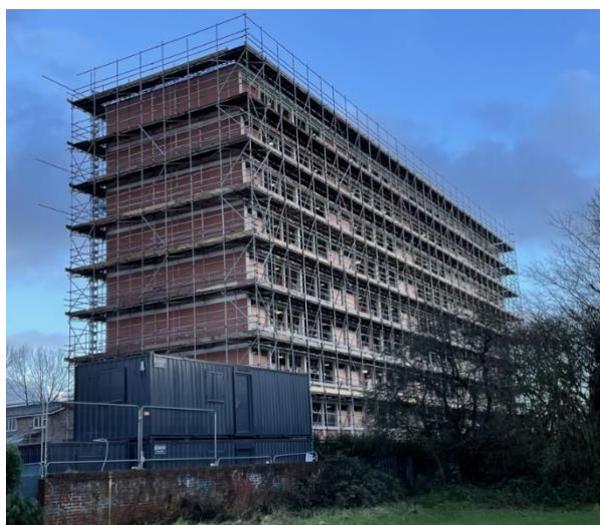
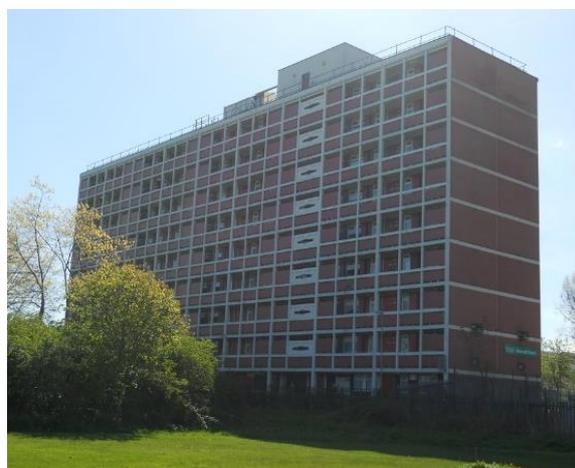
photo-Flickr

The photographs above show a before and after picture of the balcony balustrade that was installed with a red HPL panel in 2001 when under the ownership of Manchester City Council and was later replaced under Wythenshawe Community Housing Group with an A1 metal rated sheeting along with timber boxing in and spandrel panels under windows in 2022 as shown on the front page of this document.

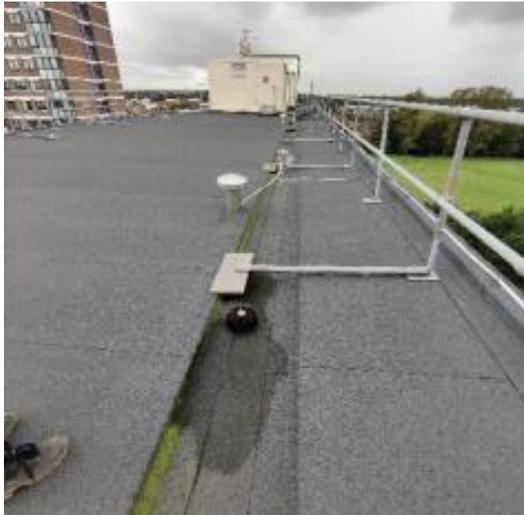
We also took the opportunity at this time to renew the roof -covering with a 'torch on' bituminous coating. New edge protection was installed to a more robust standard and new lightning protection. Refer to photographs below:

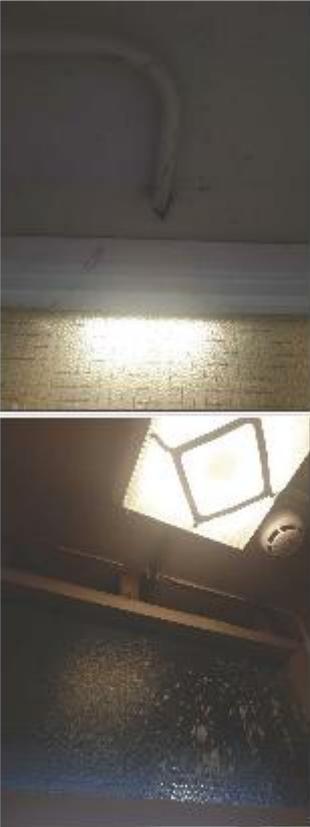
Section 1

Action	8th floor single riser by flat 64 penetration
Comments	1 x penetration seal mastic 0.5sqm fire rated boarding above door frame
Multi Photo

The first photograph shows a close-up of a white, textured fire-rated boarding installed above a door frame. A bright light source is visible, illuminating the surface. The second photograph shows a similar view from a different angle, highlighting the penetration seal and the boarding's texture.
Action	8th floor Double riser by flat 64 penetration
Comments	1 x ballt

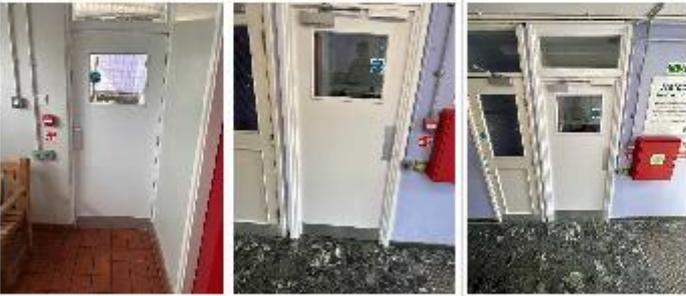
Action	Ground Floor Laundry Door
Description of Defect	Metal Door Not Fire Rated
Before

Description of Rectification	Install new fire rated door set
Action	Ground Floor Laundry Door Head Glass Panel
Description of Defect	Metal Vision Panel not fire rated
After
