# TOTAL FIRE GROUP LTD

## Fire Risk Assessment

Birch Tree Court  
Rowlandsway  
Wythenshawe  
M22 5SL

05 March 2025

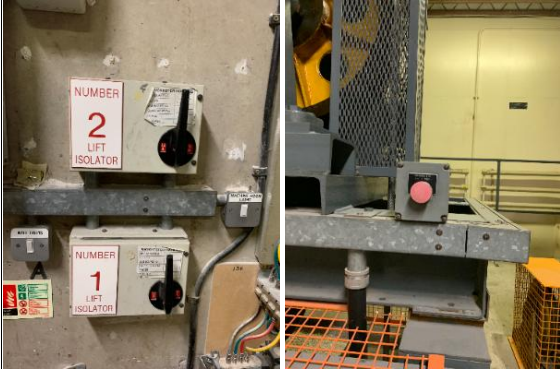
| Ref | COMMENTARY |
|---|---|
| 6.0 | Isolation and emergency stop switches for the lifts are located in the lift motor room. Photos used from previous fire risk assessment. |

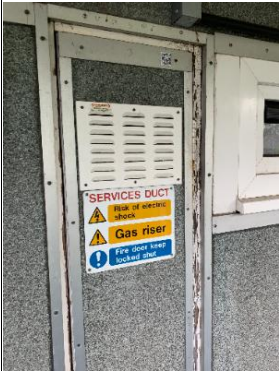
| Ref | COMMENTARY |
|---|---|
| 6.16 | Suitable hazard signage was fitted to service risers across the premises. |

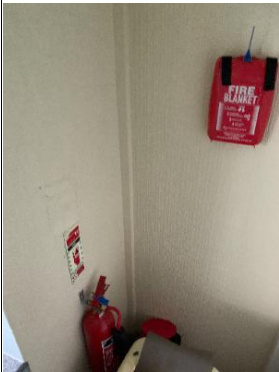
| Ref | COMMENTARY |
|---|---|
| 6.17, 6.19 | A kitchen incorporating refreshment facilities has been provided in the community room area. A fire blanket and a CO2 fire extinguisher are installed in this location. |

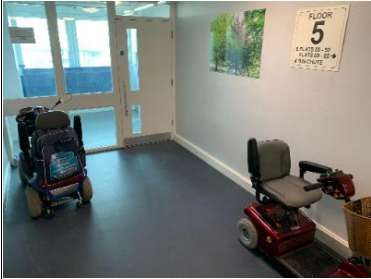
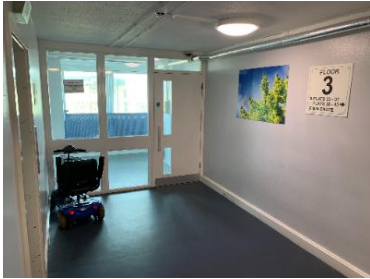
| Ref | FINDINGS |
|---|---|
| 8.7 | <p>Mobility scooters were stored in the lift lobby on the 3rd and 5th floors. Where potential sources of ignition are stored in common escape routes, particularly those through which residents have no option but to pass, persons may be placed at risk of harm.</p> <div style="display: flex; justify-content: space-around;"> </div> |

| Ref | FINDINGS |
|---|---|
| 8.7 | Arrangements should be made for the removal of the mobility scooter as soon as practicable. |

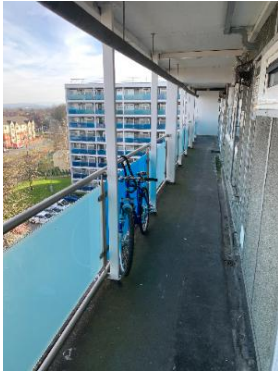
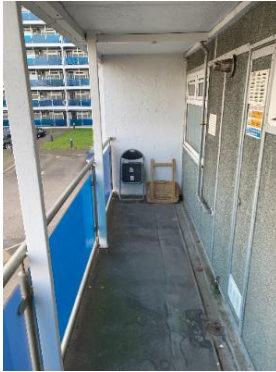
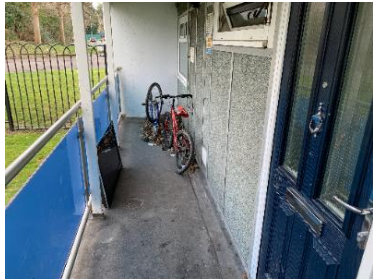
| Ref | FINDINGS |
|---|---|
| 8.7 | <p>Items were seen stored within the communal areas of the premises. Where items are stored in the communal areas they may encourage additional storage or pose a trip hazard in the event of evacuation, placing persons at risk of harm.</p> <div style="display: flex; justify-content: space-around;"> </div> |

| Ref | FINDINGS |
|---|---|
| 8.7 | It is recommended that all items are removed from the communal areas and that residents be reminded of the sterile policy in regard to communal areas. |

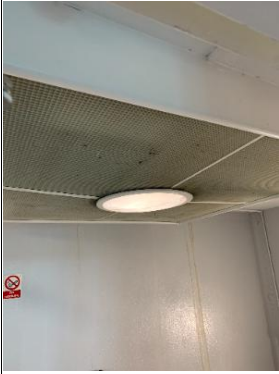
| Ref | COMMENTARY |
|---|---|
| 8.2 | <p>WCHG has previously confirmed that the vent at the head of the stairway is a permanently open vent and has an area of at least 1m<sup>2</sup>. At this time, this vent is acceptable for smoke ventilation purposes.</p> |

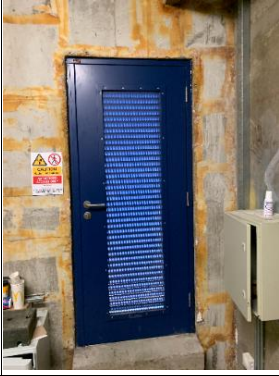
| Ref | COMMENTARY |
|---|---|
| 8.2 | <p>The door onto the roof from the lift motor room provides a means of permanent ventilation.</p> |

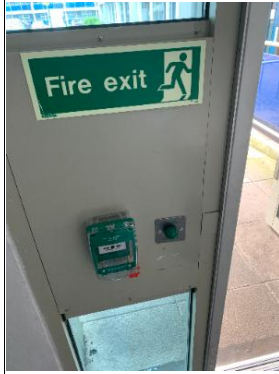
8.18-8.19 WCHG have previously confirmed that the electromagnetic locks within the premises are linked to the fire alarm and conform to BS7273-4. Where electromagnetically secured doors within the building were observed (e.g. final exits, the community room and laundry door), these were accompanied by 'push button to exit' devices and green box overrides.

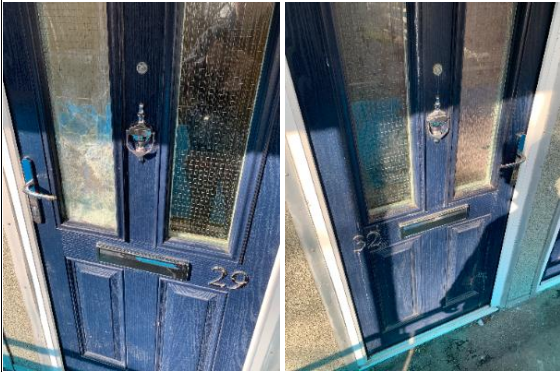
| 9.0 The Confinement of Fire: Finding(s) | |
|---|---|
| 9.1, 9.5 | <p>Deficiencies to flat entrance doors were observed at the time of the fire risk assessment:</p> <ul style="list-style-type: none"> <li>The glazing to the entrance door of flat 29 was damaged.</li> <li>The entrance door to flat 32 was damaged.</li> </ul> <p>Where deficiencies are observed regarding fire doors, the fire doors may not function as expected, and could potentially allow the spread of fire and products of combustion, placing persons at risk of harm.</p> |

| 9.0 The Confinement of Fire: Finding(s) | |
|---|---|
| 9.1, 9.5 | It is recommended where fire doors/fire door components are damaged, they be repaired/replaced. |

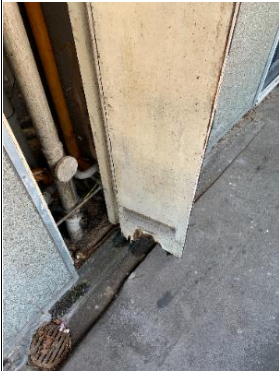
| 9.0 The Confinement of Fire: Finding(s) | |
|---|---|
| 9.1, 9.5, 9.8 | <p>It was observed at the time of the fire risk assessment that there was excessive damage to the ground floor riser adjacent to flat 3. Where fire doors are damaged they may not provide the expected level of fire resistance and may allow for the spread of smoke and products of combustion placing persons at risk of harm.</p> |

| 9.0 The Confinement of Fire: Finding(s) | |
|---|---|
| 9.1, 9.5, 9.8 | It is recommended that the door be repaired/replaced. |

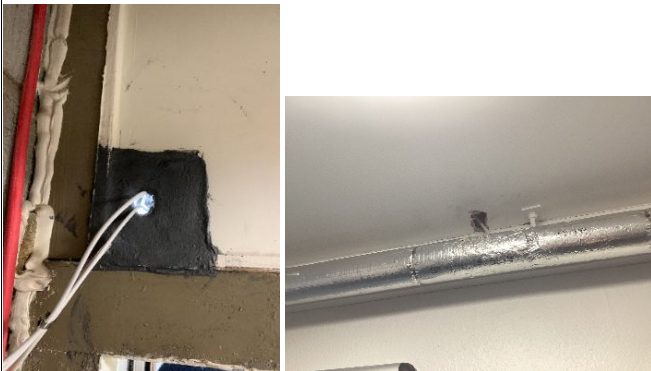
| 9.0 The Confinement of Fire: Finding(s) | |
|---|---|
| 9.1, 9.8 | <p>Breaches in compartmentation were observed at the time of the fire risk assessment:</p> <ul style="list-style-type: none"> <li>Within the ground floor electrical room there was a breach in the fire stopping in the panel above the door.</li> <li>There was a breach in the communal area on the ground floor above the notice board.</li> </ul> <p>Breaches in compartmentation may allow for the spread of fire and products of combustion, placing persons at risk of harm.</p> |

| 9.0 The Confinement of Fire: Finding(s) | |
|---|---|
| 9.1, 9.8 | It is recommended that the breaches be fire-stopped to at least 60 minutes of fire resistance. |

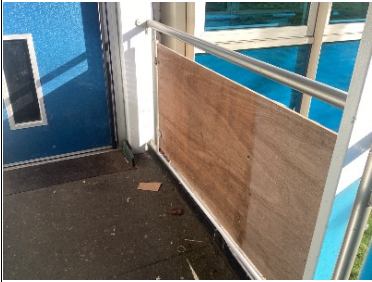
| Ref | RECOMMENDATIONS |
|---|---|
| 9.0 | It was observed that the ground-floor balcony glazing has been replaced with a piece of timber.<br> |

| Ref | RECOMMENDATIONS |
|---|---|
| 9.0 | It is recommended, in order to remain consistent with the details provided in section 9.27, the previous glazing be re-installed. (identified as 6mm heat-soaked toughened glass PAR with a Blue translucent 2.6mm interlayer, 20mm rad corners and 10mm holes. |

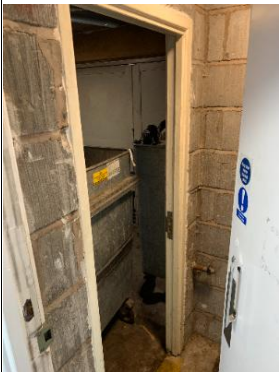
| Ref | RECOMMENDATIONS |
|---|---|
| 9.5 | The bin room on the ground floor is lobbied from the escape route by 2 x FD60s self-closing fire doors. The inner lobby door has been wedged open, as it was at the time of the previous fire risk assessment.<br> |

| Ref | RECOMMENDATIONS |
|---|---|
| 9.5 | It is recommended that the bin room's inner lobby door be unwedged and residents are advised not to wedge the door. This has not been raised as a significant finding as the outer lobby door to the bin room was also FD60s and was closed. |

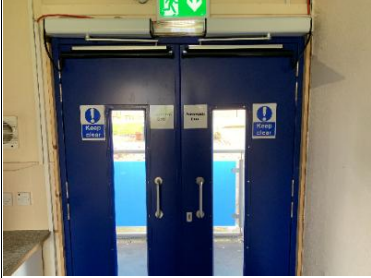
| Ref | COMMENTARY |
|---|---|
| 9.1, 9.5 | <p>The previous fire risk assessment noted that the doors leading to the scooter room are double doors and, although one side was automatic and was closed, the other side was left open and had no self-closing device. At the time of the fire risk assessment it was observed that a new automatic doorset had been installed. The doors were both shut at the time of the fire risk assessment and fitted with self closers.</p> |

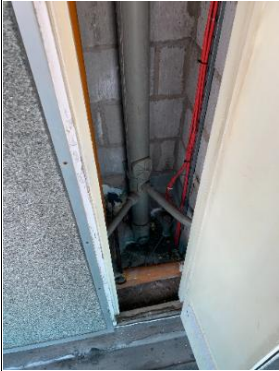
| Ref | COMMENTARY |
|---|---|
| 9.1, 9.8 | <p>The previous fire risk assessment raised a recommendation that the low-level vents that contain the electrical units and TV aerial splitters and cables be sealed. At the time of the fire risk assessment it was observed in each riser that was part of the sample, the vents had been sealed on the internal face.</p> |

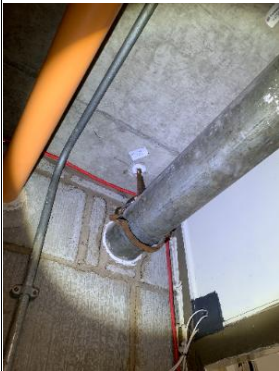
| Ref | COMMENTARY |
|---|---|
| 9.1, 9.8 | <p>The previous fire risk assessment noted that there were breaches leading from the electrical room on the ground floor leading to the sprinkler valve room. WCHG have confirmed that this breach has been fire-stopped. Although not specified on the information provided to the assessor it is assumed that this breach has been fire stopped to at least 60 minutes of fire resistance as per the previous recommendation.</p> |

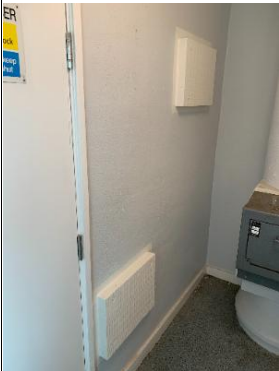
| 9.8 | <p><b>Extract from previous fire risk assessment:</b> The air bricks between the electrical room and bin chute room on the seventh floor have been appropriately fire-stopped.</p> |

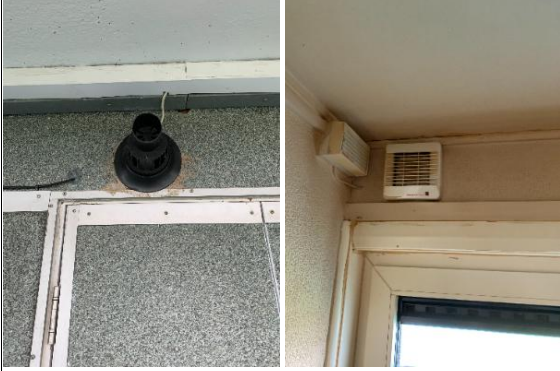
| 9.11 | <p>In the flats that were viewed during this and previous Fire Risk Assessments, it was confirmed that the ventilation arrangements for the kitchen and bathroom were located on the external wall onto the open deck and did not pass through any other compartmentation. The extraction passes out of the flats at high level and, therefore does not affect persons escaping past. Extraction from the laundry was observed to lead directly to outside.</p> <div data-bbox="236 1160 798 1529"> </div> |

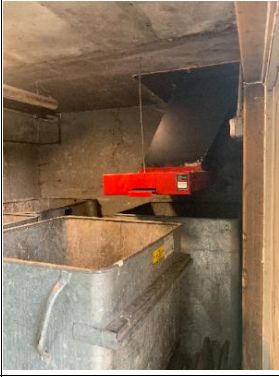
| 9.16 | <p>In the bin room on the ground floor, the bin in use is located adjacent to a lid that has a fusible link which enables the lid to self-close over the bin should a fire occur. This is to prevent the fire, smoke and toxic gases from spreading up the chute. The fusible link is checked annually by an appointed contractor and a label indicated that this was last carried out on 26/04/2026. Both the main bin room and the chute rooms are provided with a means of ventilation. The bin chute hoppers on each of the upper floors are metal and self-closing, with rubber seals fitted.</p> <div data-bbox="236 1688 515 2063"> </div> |

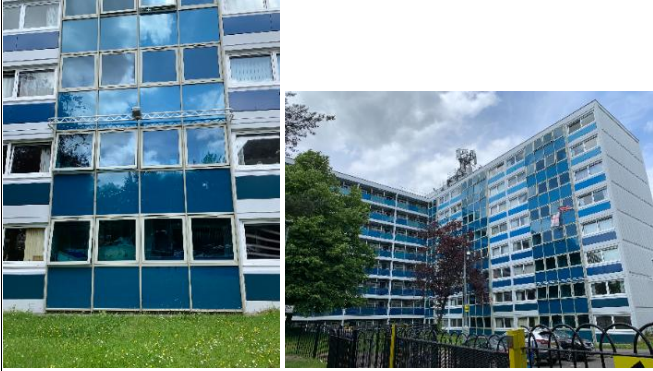
| 9.27 | <p>WCHG has communicated to our assessor that the building is of panel system-type construction consisting of concrete walls and floors. There are also portions of curtain wall glazing around the enclosed balconies within resident flats.</p> <div data-bbox="236 421 892 790"> </div> |

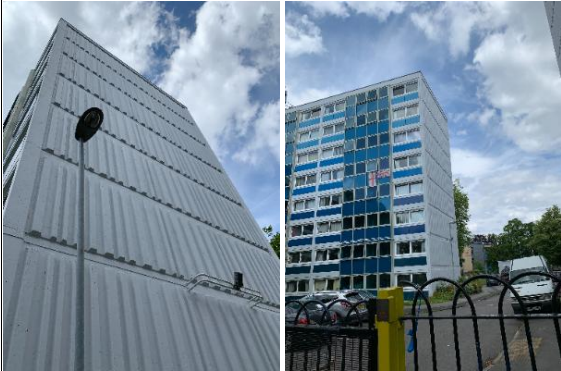
| 9.27-9.28 | <p>As was recommended at the time of the previous assessment, a consultant attended site on behalf of WCHG and took a core sample from the gable ends of the building. It was confirmed that no other material of insulation was present behind the gable ends, therefore no further action has been taken.</p> <div data-bbox="236 898 799 1267"> </div> |

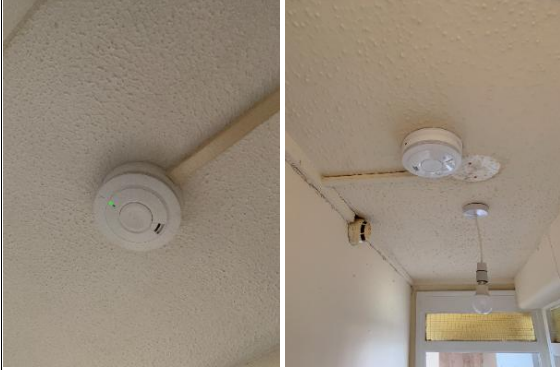
| Ref | COMMENTARY |
|---|---|
| 10.6 | <p>All of the resident flats accessed were provided with BS5839-6 Grade D LD1 fire alarm systems and WCHG have previously confirmed that that this provision is consistent throughout all of the flats in the building.</p> |

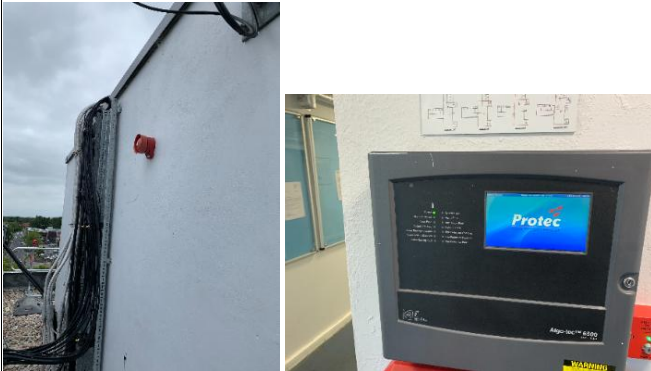
| Ref | COMMENTARY |
|---|---|
| 10.6 | <p>The common area fire alarm and detection system incorporates smoke detection throughout commonly used areas and heat detection in the hallways of each resident flat. The fire alarm panel for the system is located in the lift lobby at ground floor level and appeared healthy at the time of the assessment. It was confirmed to our assessor that the system is addressable. It has been confirmed to our assessor that, although the common fire alarm system is silent through the majority of the premises, it is audible in plant and service areas, including on the roof where a sounder is present.</p> |

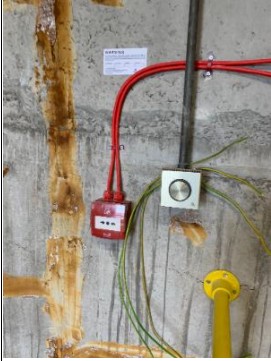
| Ref | COMMENTARY |
|---|---|
| 10.7 | <p>As previously recommended, a manual call point linked to the common fire alarm system has been installed in the lift motor room.</p> |

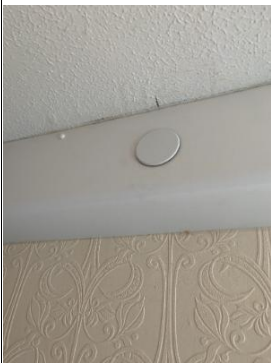
| Ref | COMMENTARY |
|---|---|
| 12.8-12.9 | <p>A BS 9251 sprinkler system has been installed. In each flat, there are concealed sprinkler heads located in the hallway, each bedroom, the lounge, any enclosed balcony and the kitchen. In addition, there are also sprinkler heads located in the ground floor plant areas. There are control valves for each floor located in the dry riser cupboards. A pump and water tank for the sprinkler system have been provided in the tank room accessed via the lift motor room. The system is maintained and serviced by an approved contractor on a quarterly basis and Argus also attend weekly to visually check the sprinkler system.</p> |

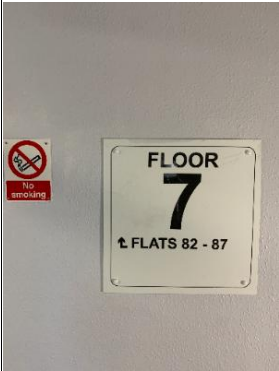
| Ref | FINDINGS |
|---|---|
| 13.15-13.16 | Wayfinding signage that has the floor number and directional signage to the flats, including flat numbers, is now displayed in the lift lobbies and on the stairway landings. |

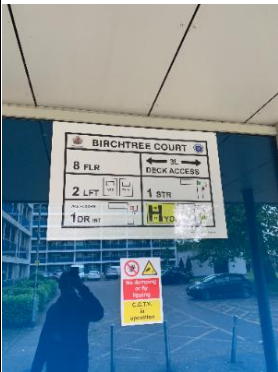
| Ref | FINDINGS |
|---|---|
| 14.11 | <p>Signage indicating certain provisions of the building is displayed externally, which may be used to assist attending Fire and Rescue Service personnel.</p> |
